WL-TR-94-2092

RECIRCULATING CAVITY CASING
TREATMENT FAILURE

FINAL REPORT FOR 04/01/93 - 02/01/94

AERO PROPULSION AND POWER DIRECTORATE
WRIGHT LABORATORY
AIR FORCE MATERIEL COMMAND
WRIGHT PATTERSON AFB OH 45433-7650

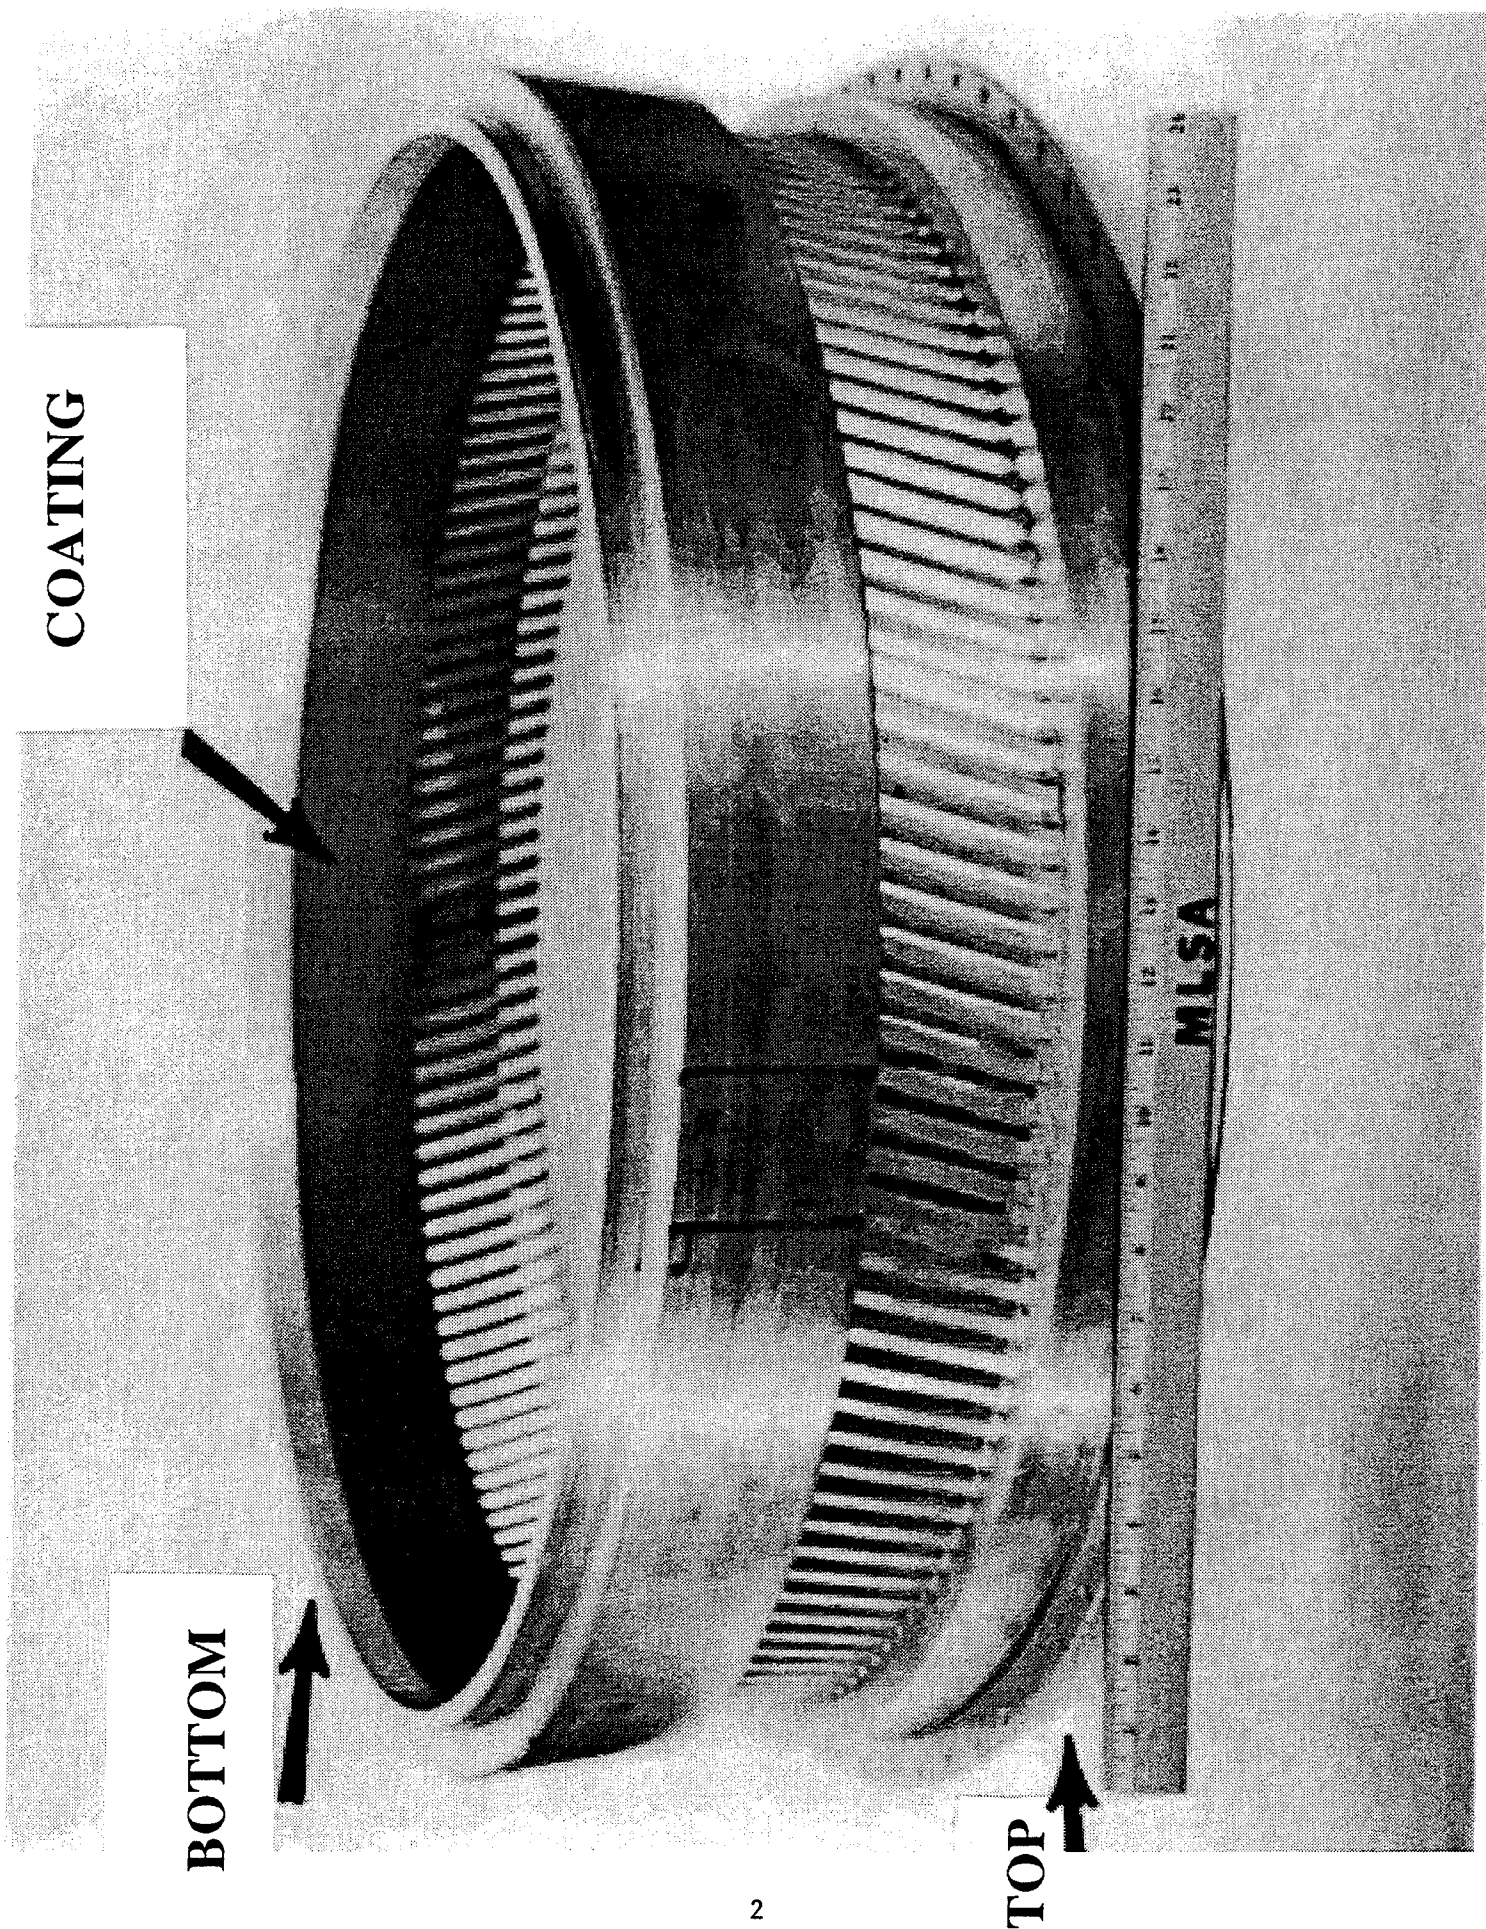
On 19 May 1993, the Test Article was boroscoped. The Recirculating Cavity Casing Treatment was found to be extremely discolored from the heat and some of the fingers were cracked. The casing treatment was removed and an overall view of the 6061-T6 aluminum alloy casing treatment can be seen in Figure 1.

Figure 1 Overall View of the 6061-T6 Recirculating Cavity Casing Treatment

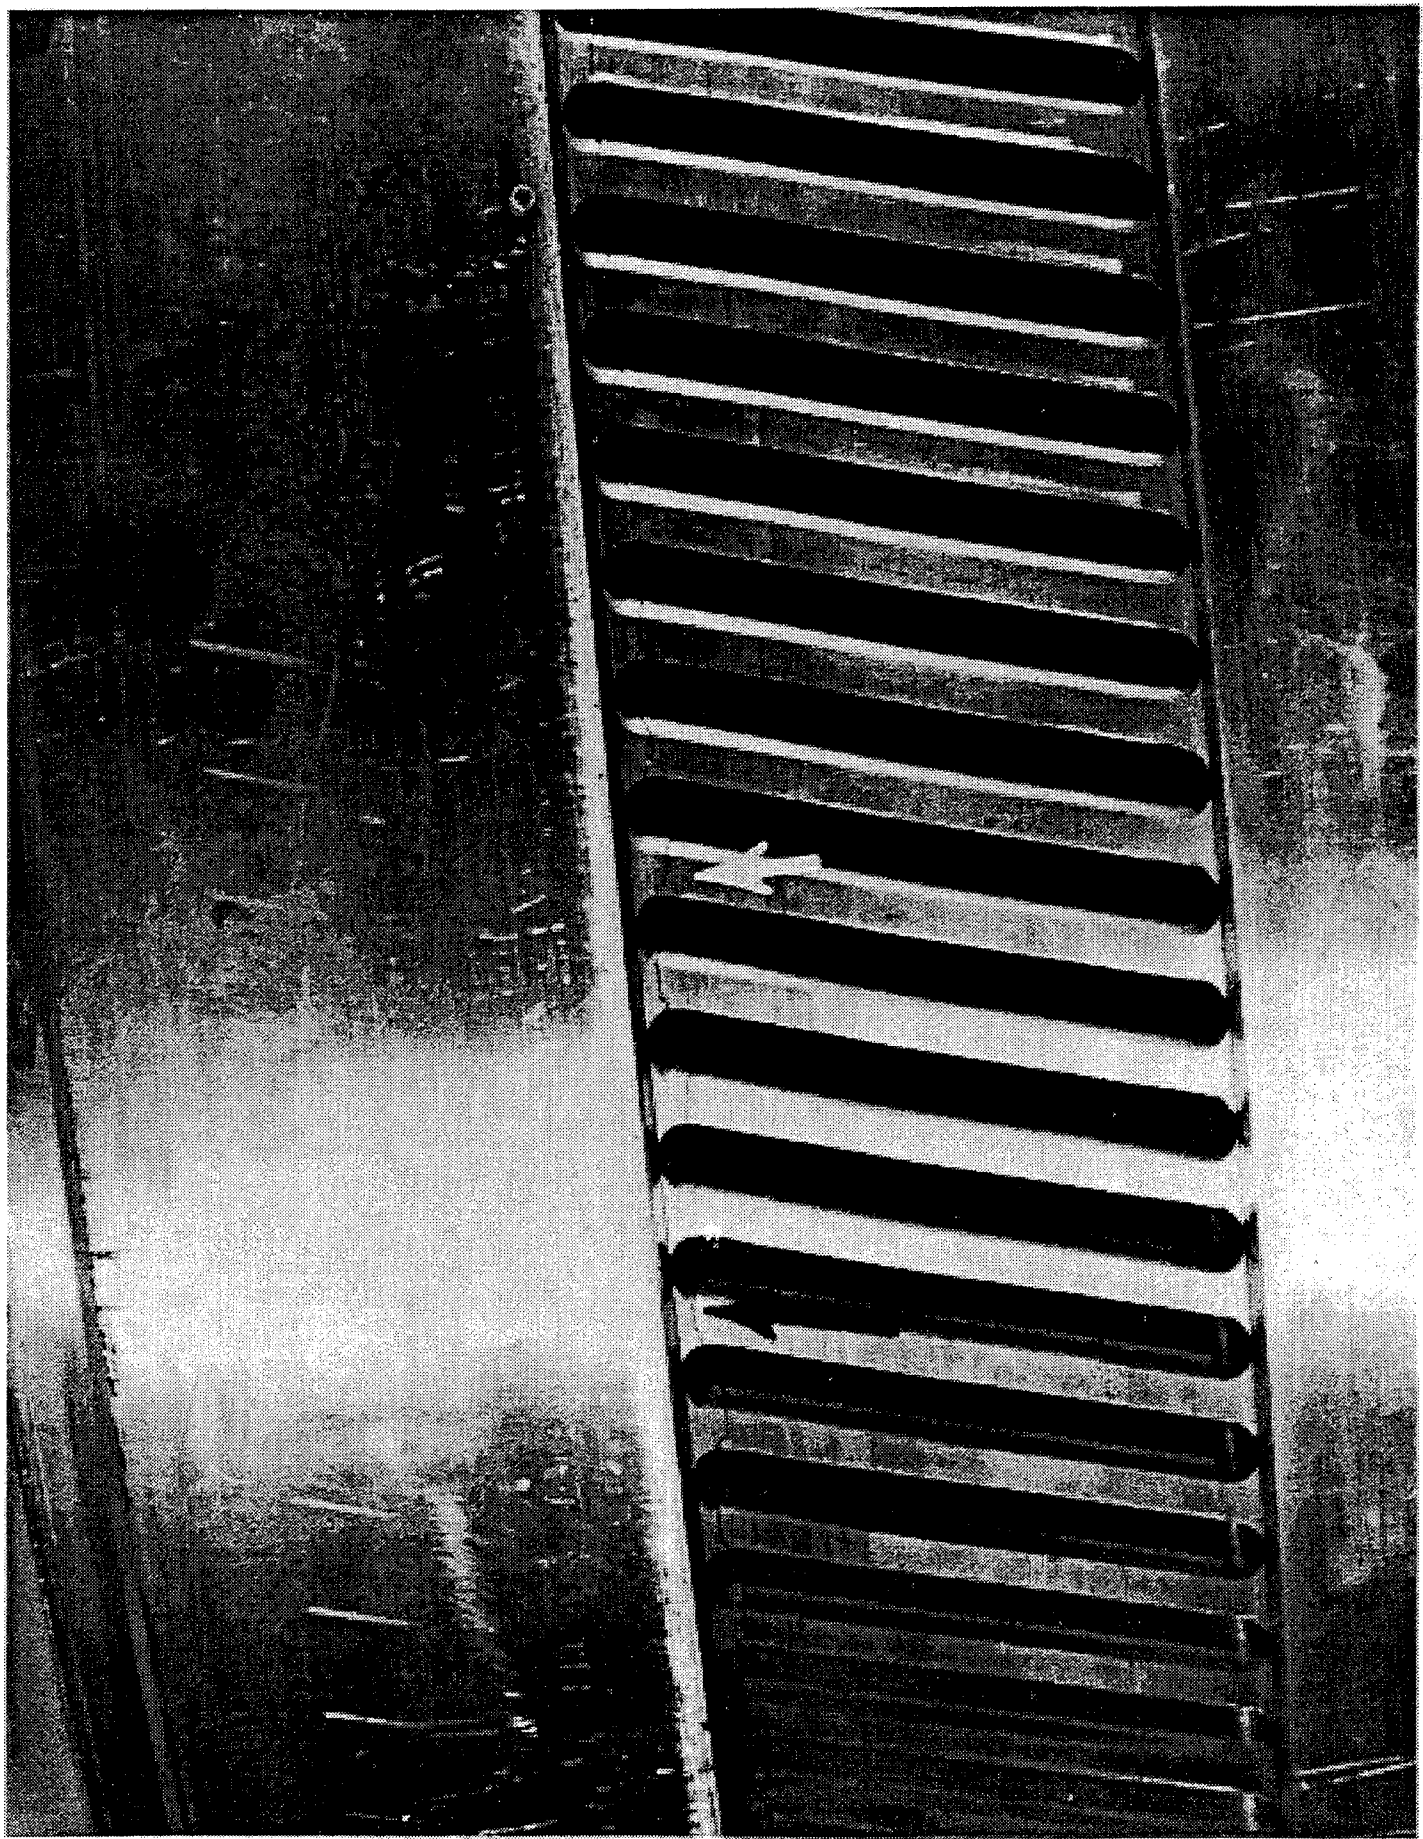
On 19 May 1993, the Test Article was boroscoped to find cracked fingers on the Recirculating Cavity Casing Treatment. See Figure 4. The casing treatment was then removed and failure analysis was started.

Figure 4 Photograph of the Cracked Fingers

After reviewing Figure 4, it can be seen only one end of the fingers developed cracks. This end is the downstream end of the casing seeing the hottest air flow. Cracks appear to originate from the two corners of the fingers, the corner being the intersection of the width and the thickness dimension of a finger. A close-up view of a crack in the finger can be seen in Figure 5. Scanning electron microscopy, Figure 6, determined these corner cracks to be due to mechanical fatigue. Scanning electron micrographs show fatigue striations indicative of mechanical fatigue, Figures 7 and 8.

Since fatigue cracking of the fingers is related to softening of the aluminum alloy, it is recommended 6061-T6 aluminum alloy not be used for this application.

Aluminum alloys 2219 and 2618 have better fatigue crack growth resistance under prolonged exposures between 300°F and 600°F and should be considered as alternate materials.

Although the suggested replacement aluminum alloys would work under the conditions specified and are lightweight, they are expensive and not readily available to a test program already on a tight time constraint. Since weight is not important in a ground test, the plain carbon steel 4041 will handle the rugged test environment, is available in stock at most metal distributors, and is easily machined.

It is also the recommendation of the paper to fully instrument the new casing treatment with thermocouples to analyze the effect of the elevated temperatures. Since the cracks occurred in the corners, it was suggested to increase the radius of the corners. This will also shorten the total machining time.

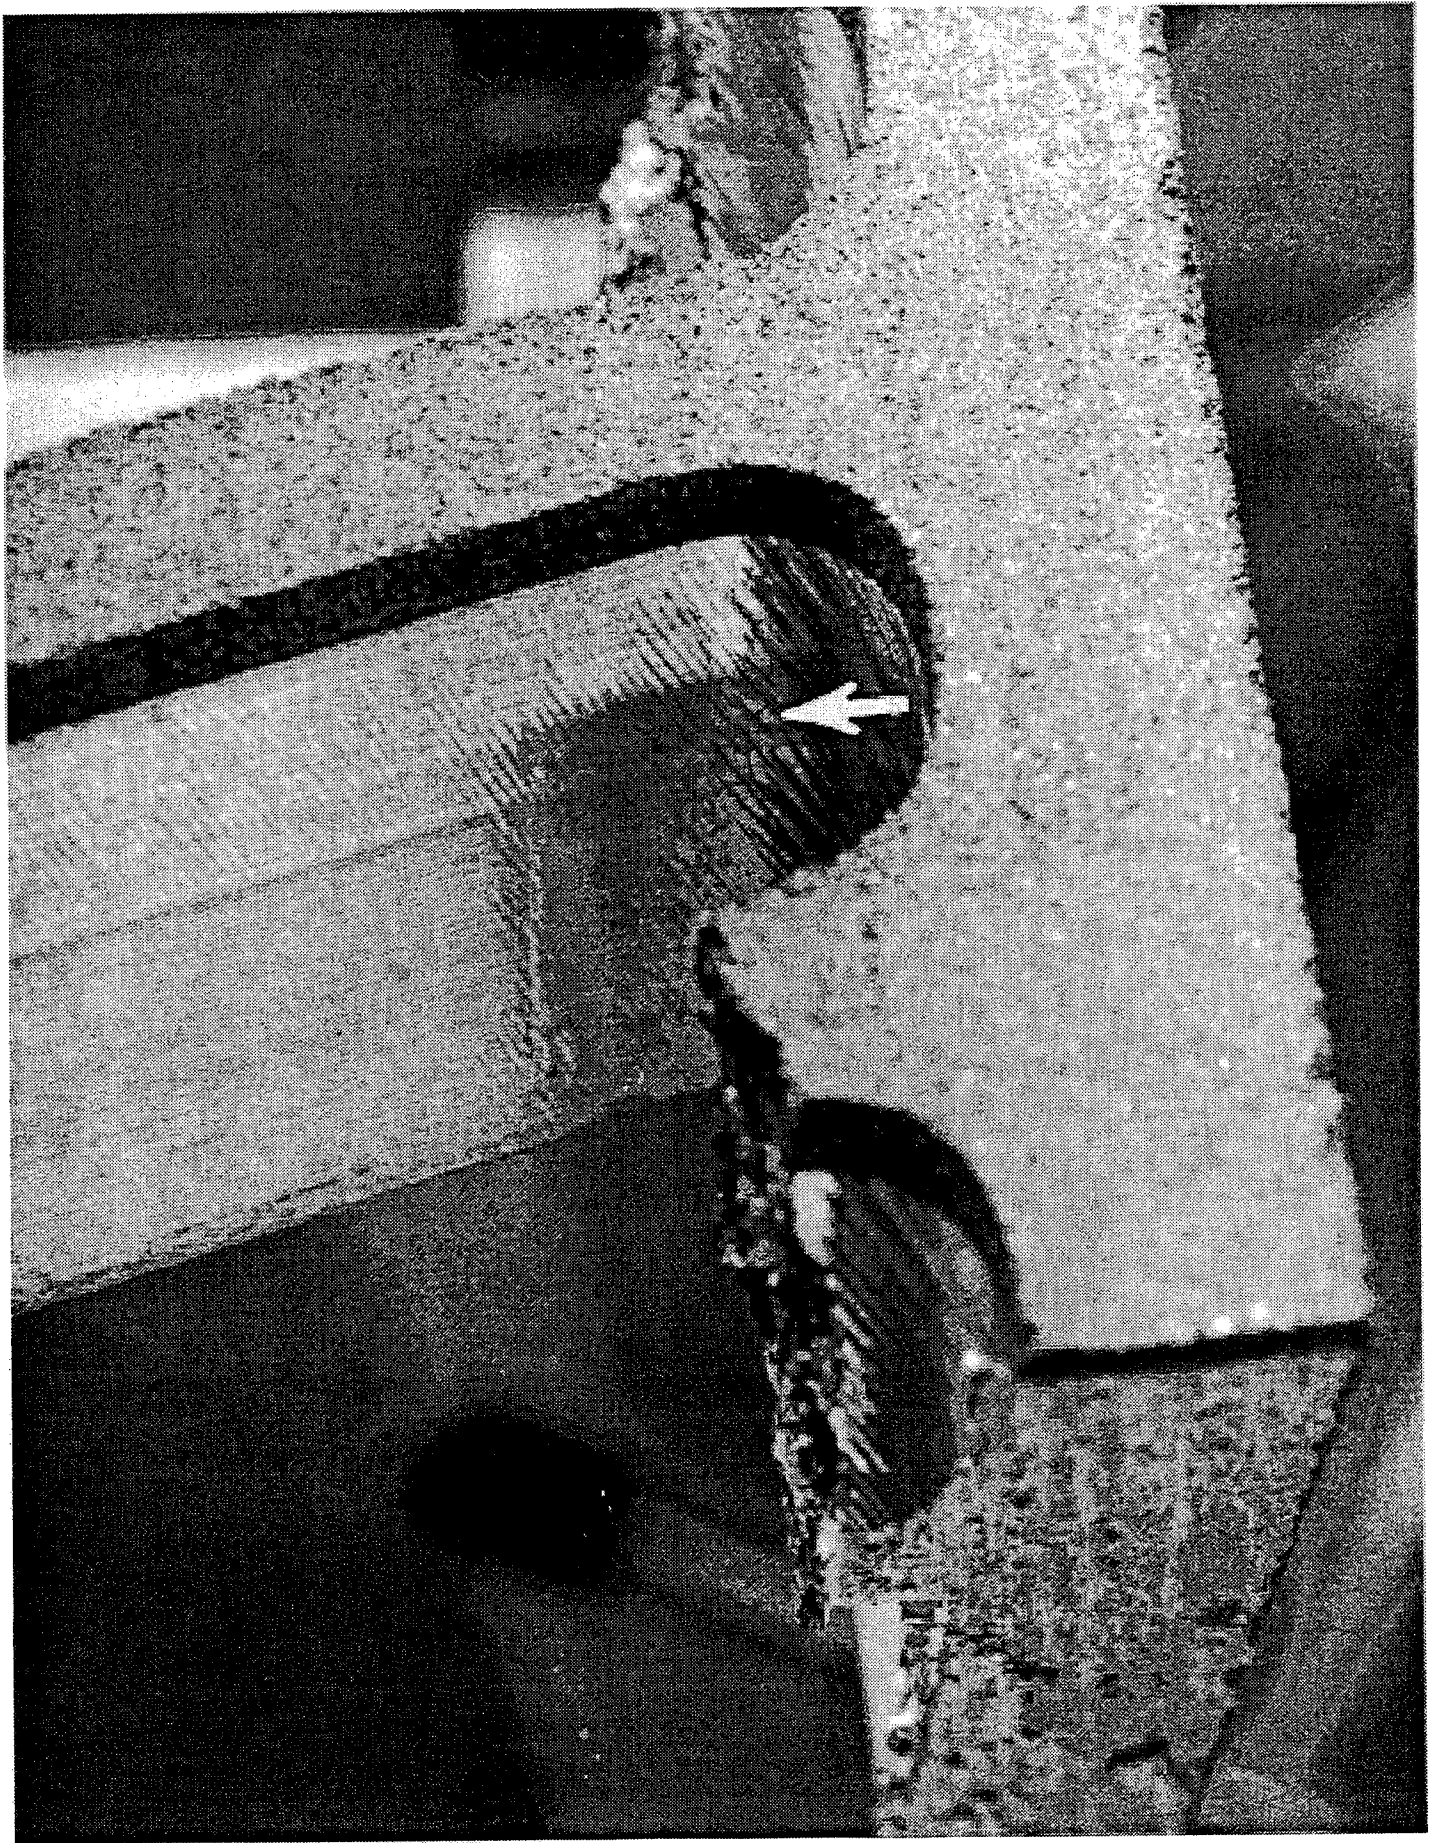
Hardness measurements on the cracked fingers showed substantial variation along the length of the finger. In the area where the fracture occurred, the hardness is Rockwell E (R_E) 67. In the middle of the finger, the hardness is R_E 63. The area at the bottom of the finger farthest from the fracture site is R_E 78. The minimum recommended hardness according to the American Society for Testing Materials Specification 2658 for 6061-T6 is R_E 85. The original design specifications did not call out a minimum desired R_E hardness value. The decreased hardness numbers are due to the extreme temperatures seen by the casing treatment.

Figure 5 Close-Up View of a Cracked Finger

All of the hardness numbers along the finger length were lower than the minimum recommended number of R_E 85 for 6061-T6. This would suggest the aluminum alloy softened due to exposure to high temperatures. Aluminum 6061-T6 will soften when exposed to temperatures greater than 300°F. Although the hardness in the middle portion of the finger is lowest, cracks did not originate in this region. The presence of a sharp radius at the junction and a low hardness caused the failure.

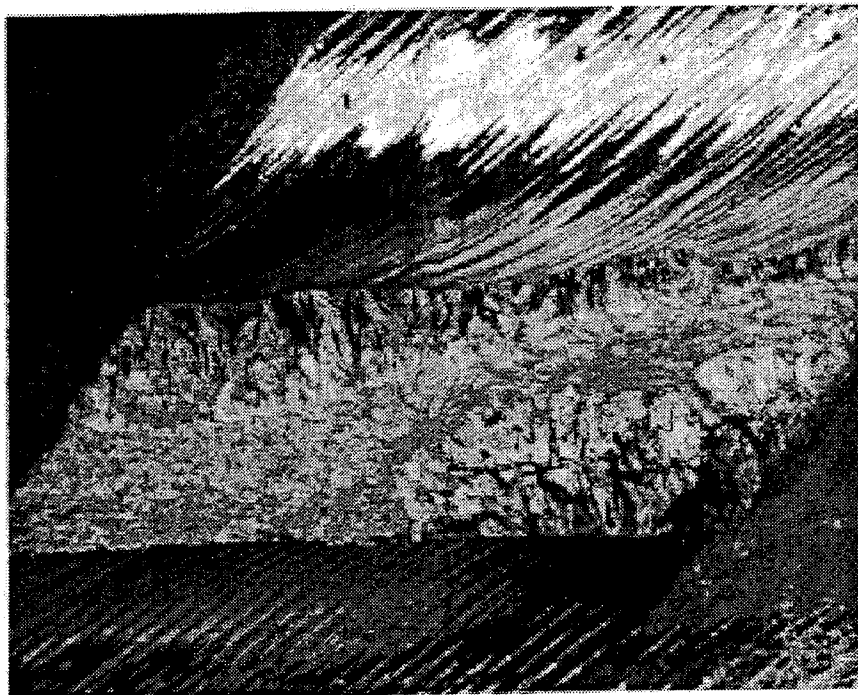
Figure 6 Optical Micorgraph Depicting Two Corner Cracks
Mag: 7.2X

Almost all of the cracked fingers exhibited corner cracks. The corner cracks were initiated and propagated by fatigue. Fatigue crack propagation data for 6061-T6 are available only for room temperature and 300°F temperatures. These data show at 300°F, fatigue crack growth rates are twice as fast as at room temperature. This suggested exposure to higher temperatures would only be further detrimental to crack propagation. Data on yield strength show 30 minutes exposure to 300°F decreases the yield strength from 42 Ksi to 36 Ksi. This would also imply reduced hardness.

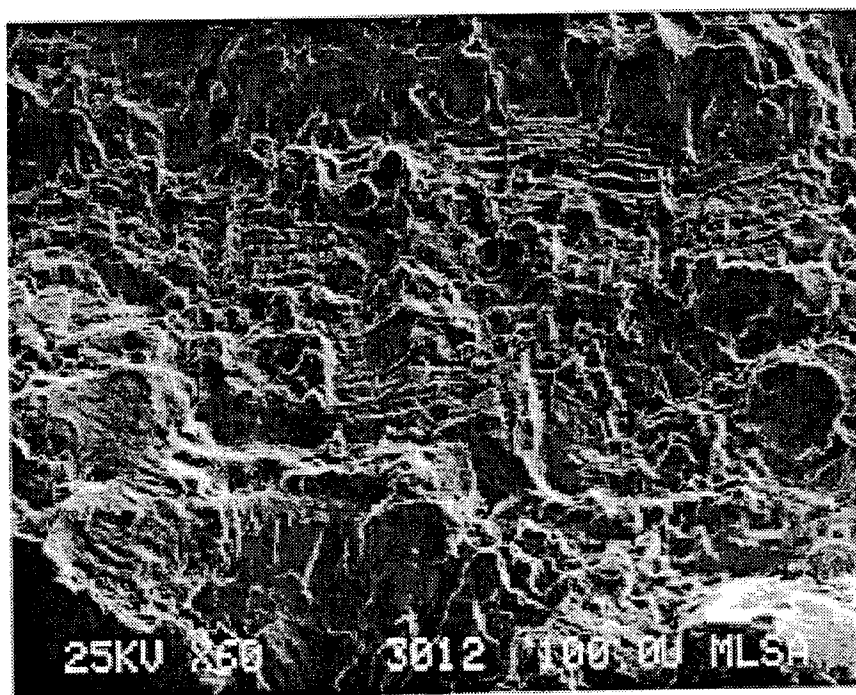
Figure 7 Scanning Electron Micrograph Fatigue Striations
Mag: 60X

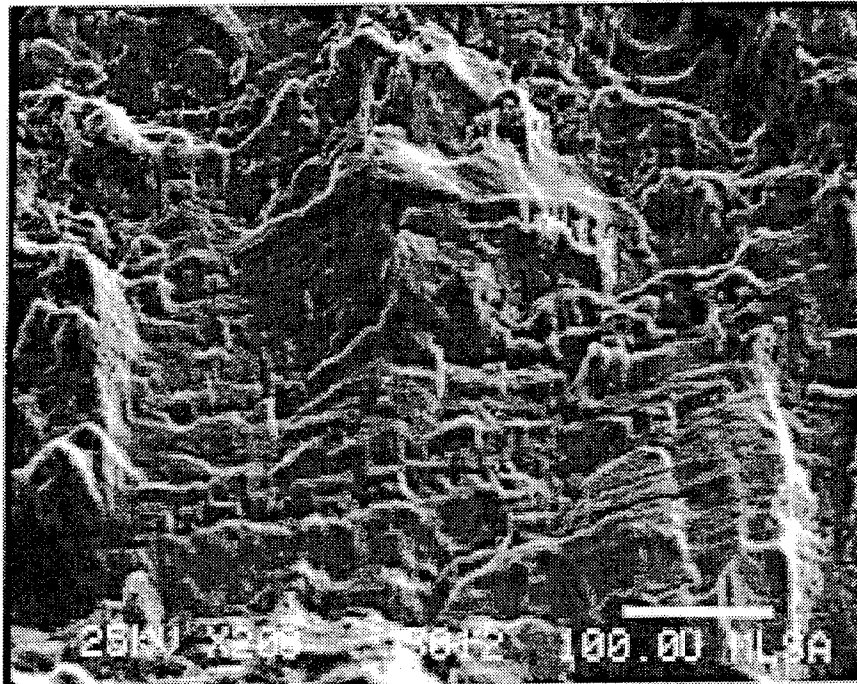
Figure 8 Higher Magnification View of Figure 7
Mag: 200X
